STATE OF CALIFORNIA
DEPARTMENT OF CALIFORNIA HIGHWAY PATROL
MULTIDISCIPLINARY ACCIDENT INVESTIGATION TEAM (MAIT) REPORT
CHP 558 (Rev. 9-25) OPI 060 (MAIT use only)

AGENCY/AREA
CHP San Gorgonio Pass Area

CASE NUMBER
BD-070-25

MAIT INVESTIGATION

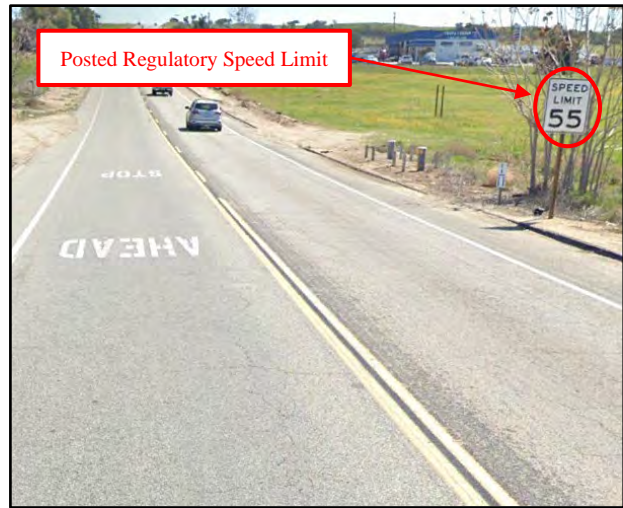
Figure 2. Posted regulatory speed limit sign on Cherry Valley Boulevard eastbound, located 0.5 mile west of the crash location. Source: Google Earth

The posted regulatory speed limit sign on Cherry Valley Boulevard westbound and eastbound was 55 miles per hour (Figure 1 and Figure 2). Roberts Street did not have posted speed limit signs.

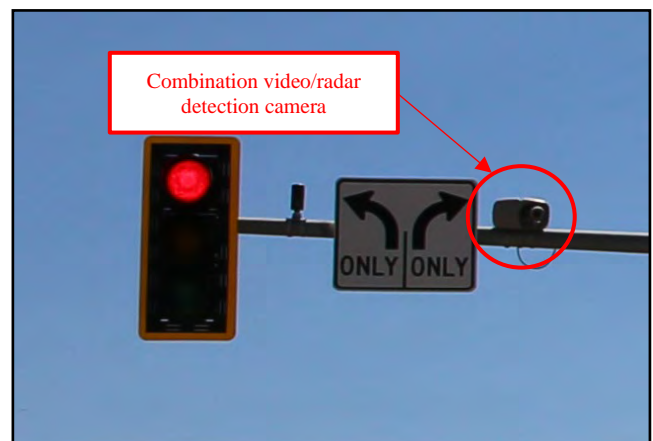
Figure 4. Combination video/radar detection camera facing Roberts Street in the south direction.

The intersection was controlled by traffic signals in all directions. Although there were inductive loop detectors located in the traffic lanes, the traffic signal operation at this intersection was actuated by combination video/radar detection cameras installed on the traffic signal mast arm (Figure 3 and Figure 4). Detection cameras only detect vehicles to adjust light timing like a motion sensor. They do not record video or take photos.

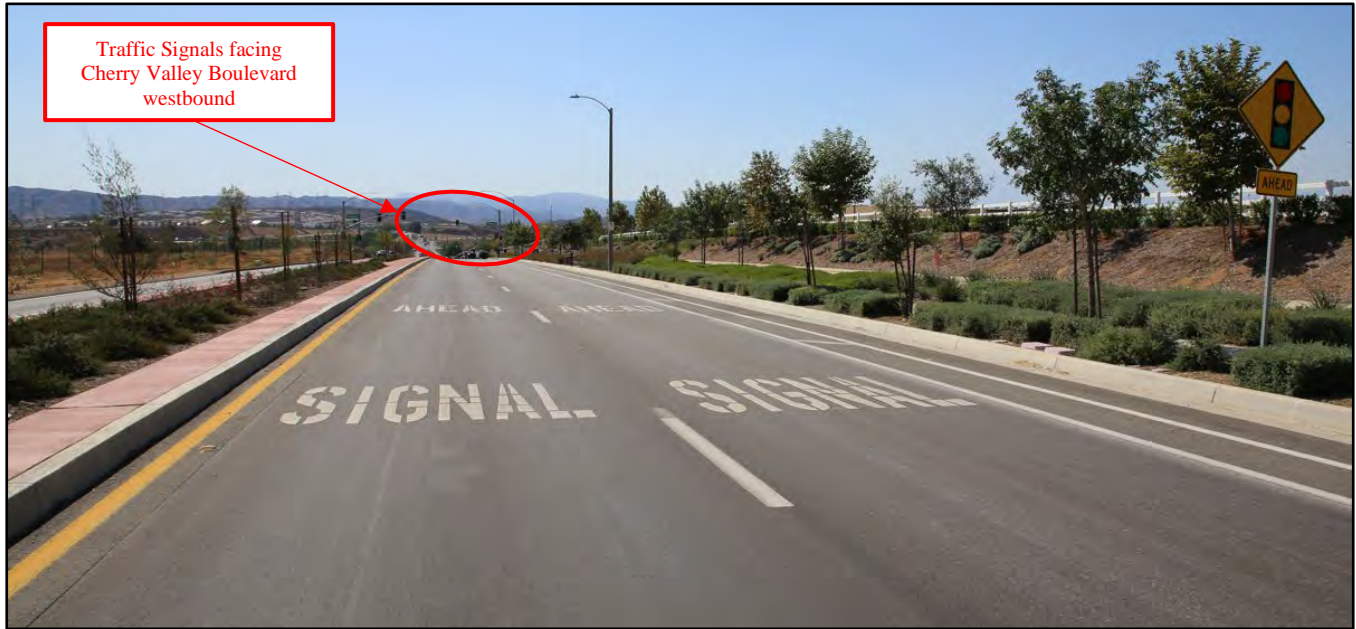
Figure 11. View of traffic signals facing Cherry Valley Boulevard westbound, 675 feet east of the signal lights.

The image below shows the line of sight and sight distance to the traffic signals facing Cherry Valley Boulevard westbound towards the crash location (Figure 11).

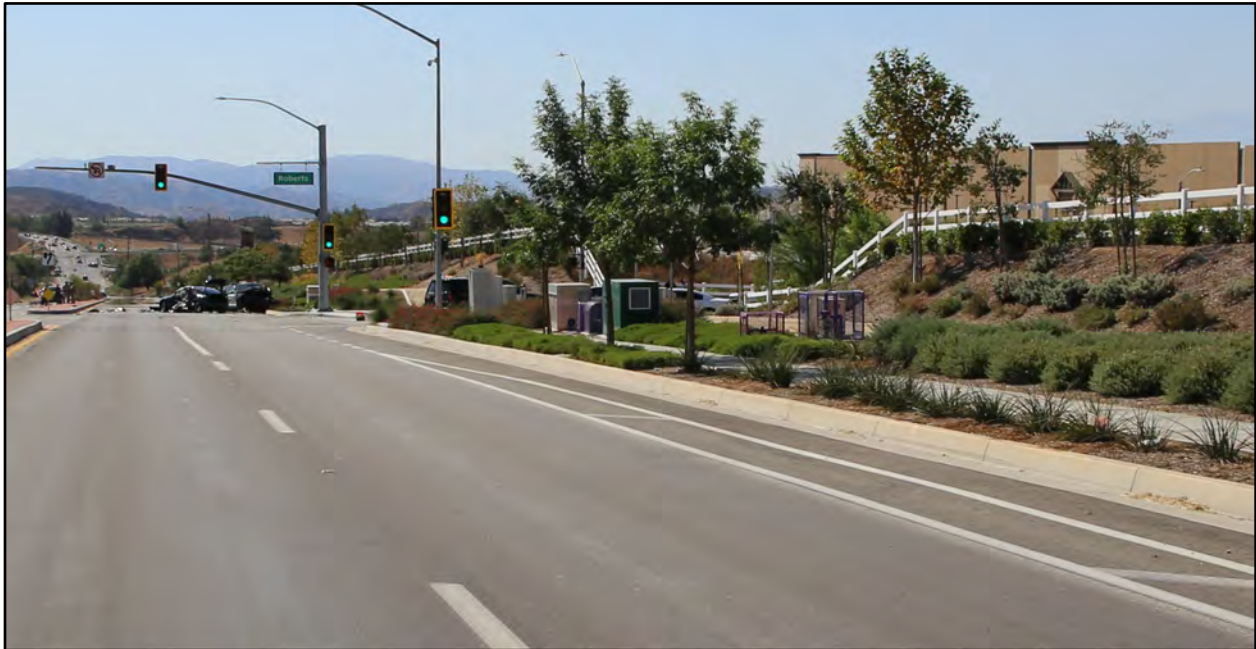
Due to several electrical control cabinets and irrigation cages located on the northeast corner of the intersection, the view of traffic approaching on Cherry Valley Boulevard westbound was obscured from drivers on Roberts Street. Likewise, the view of traffic approaching on Roberts Street southbound was obscured from drivers on Cherry Valley Boulevard westbound.

Figure 12. View from Cherry Valley Boulevard westbound looking toward Roberts Street southbound

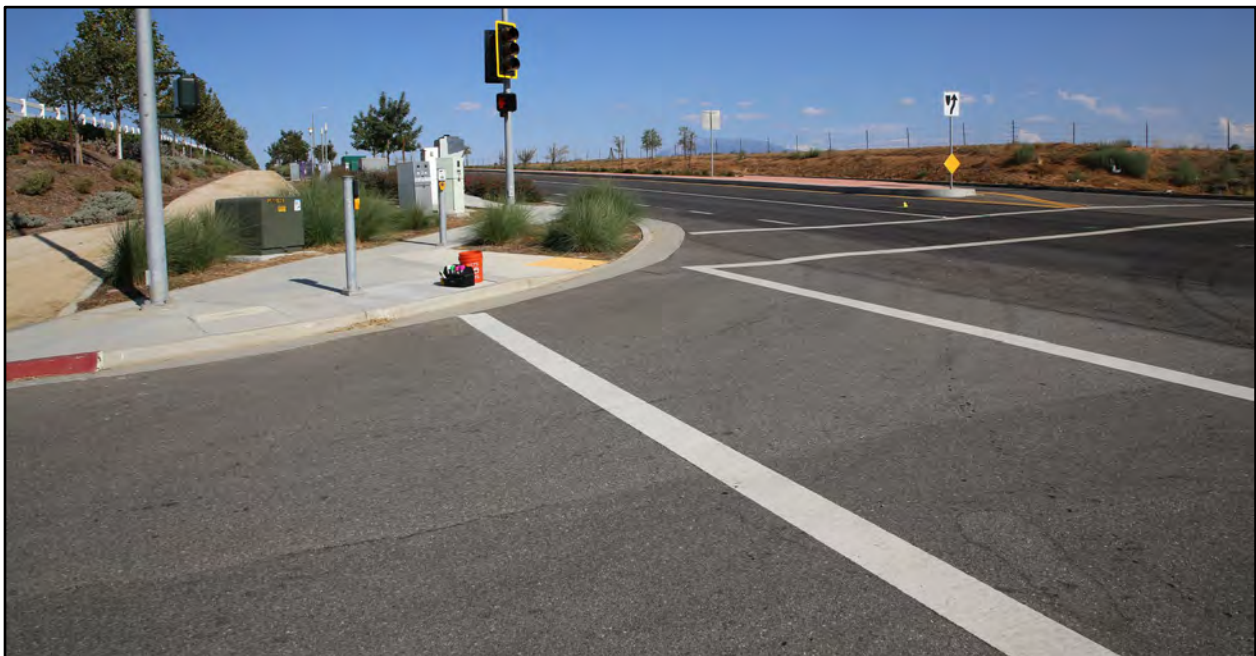
Figure 13. View from Roberts Street southbound looking towards Cherry Valley Boulevard east of the intersection.

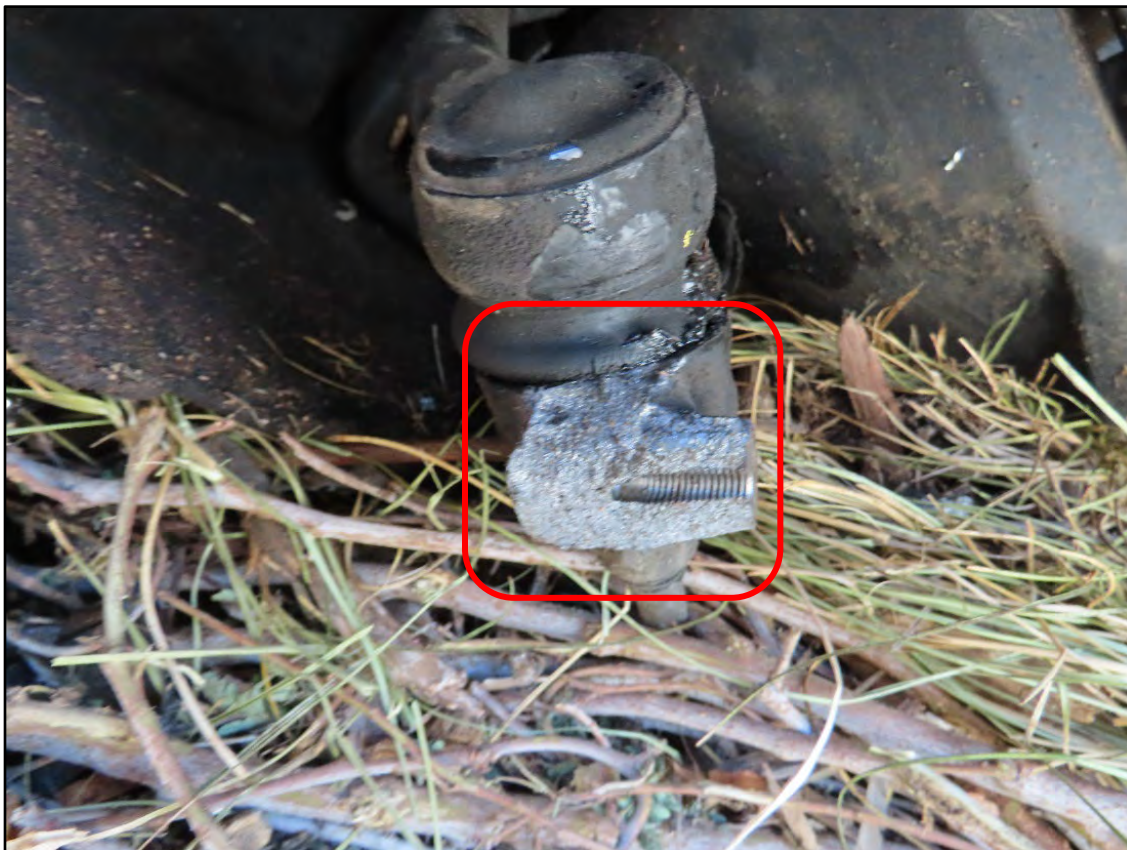
Tie rod assemblies were used to connect the steering gear to the left- and right-side steering knuckles. Each tie rod assembly consisted of an inner tie rod, an outer tie rod end, and a lock nut. Each tie rod assembly utilized ball socket joints. The left- and right-side inner joints had no discernable movement. The intermediate shaft was detached from the steering gear. Due to this condition, there was no correlating movement at the steering knuckles when the steering wheel was manipulated. The steering gear and surrounding components were fractured and displaced rearward. The left-steering knuckle was fractured at the outer tie rod mount (Figure 20). The exposed fractured surface had a rough crystalline appearance, which is characteristic of an instantaneous failure that is usually associated with a shock load. A shock load is a sudden and powerful force that exceeds the strength of the metal.

Figure 20. Fractured left steering knuckle.

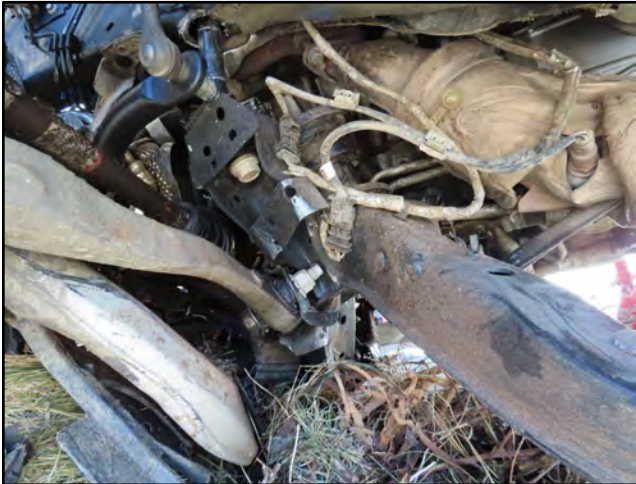
The steering axle was equipped with an independent coil-spring suspension. The wheels were independently connected to the frame, utilizing strut assemblies, steering knuckles, and ball joint assemblies at both sides. Strut assemblies at each side dampened the suspension. A sway bar supplemented the suspension. The left- and right-front suspension components sustained multiple fractures and were displaced rearward (Figure 21 and Figure 22). The exposed fractured surfaces had a rough crystalline appearance.

Figure 21. Displaced left-side suspension.

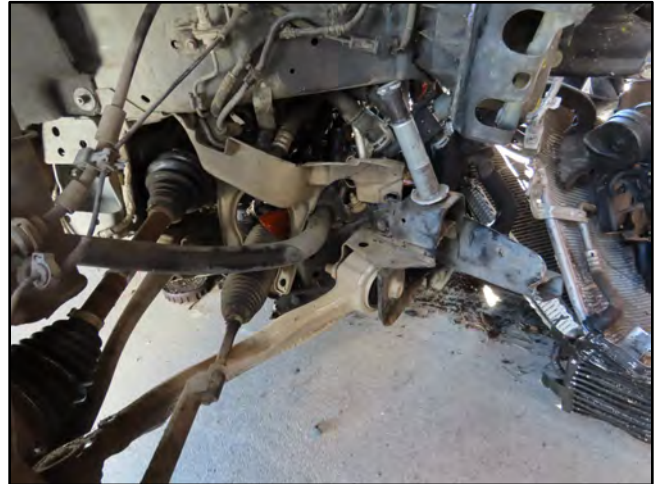
Figure 22. Displaced right-side suspension.

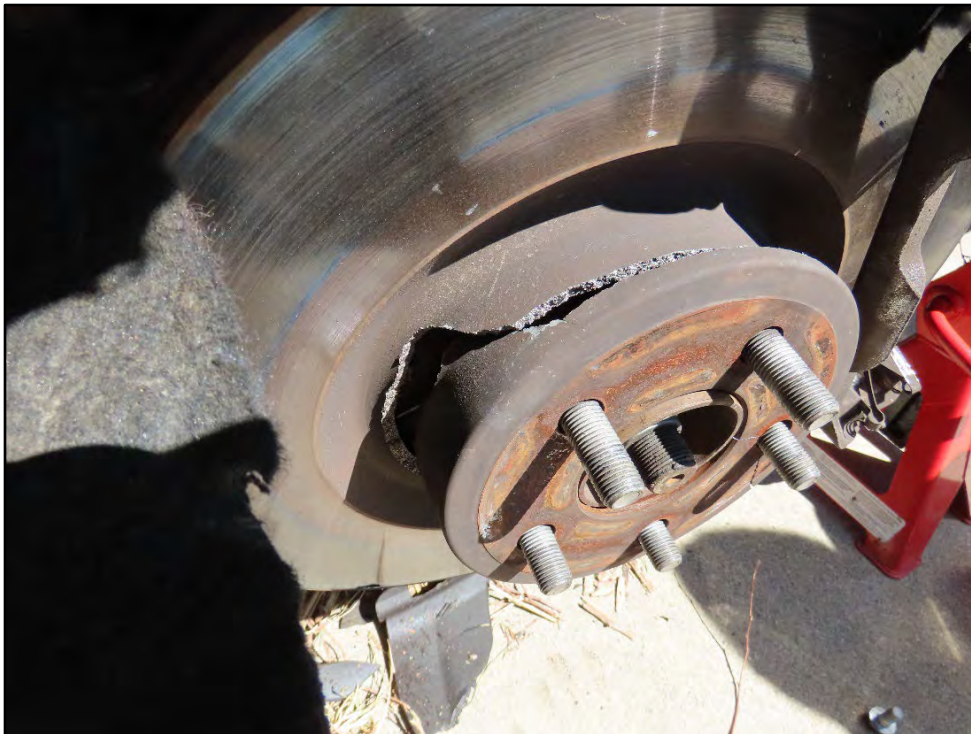
The left-front brake rotor was fractured and separated (Figure 24). The exposed fractured surfaces had a rough crystalline appearance.

Figure 24. Fractured left-front brake rotor.

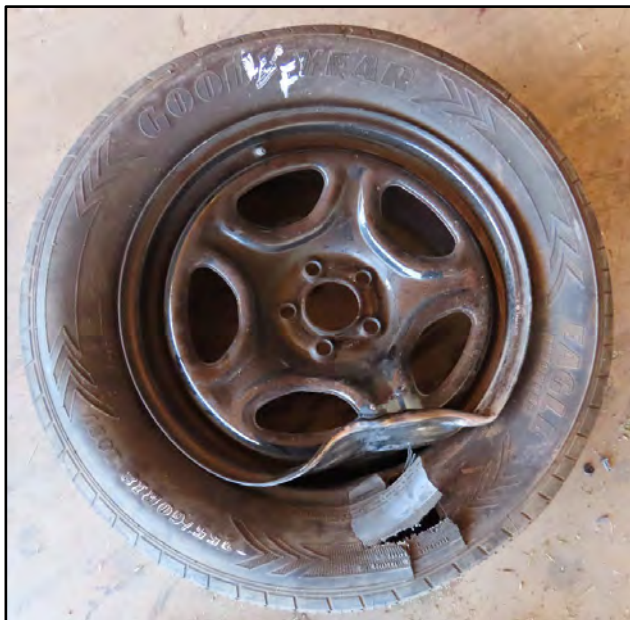
The outboard sidewall of the left-front tire sustained tears at the 6 o'clock position, and the outboard wheel flange sustained a radial collapse from the 5 to 7 o'clock positions (Figure 25). The inboard wheel flange of the left-front wheel sustained a radial bend at the 11 o'clock position (Figure 26).

Figure 25. Outboard view of left-front tire and wheel assembly.

The damage sustained to the tire and wheel assemblies was caused by contact with another vehicle and other roadway objects.

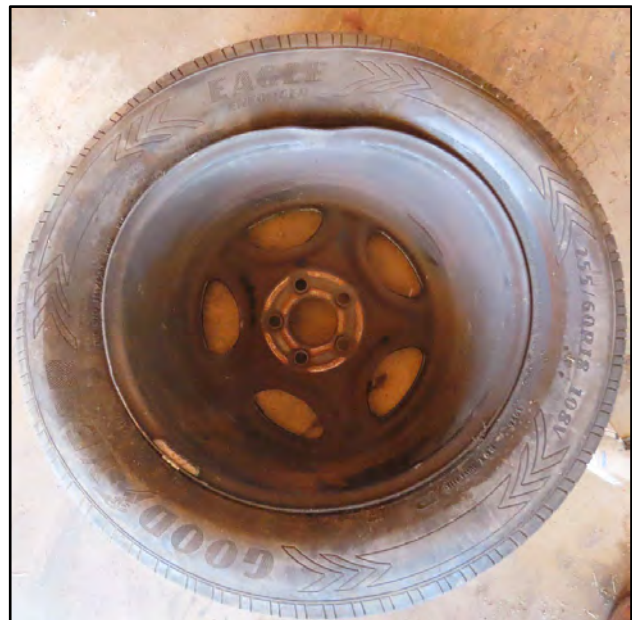
Figure 26. Inboard view of left-front tire and wheel assembly.

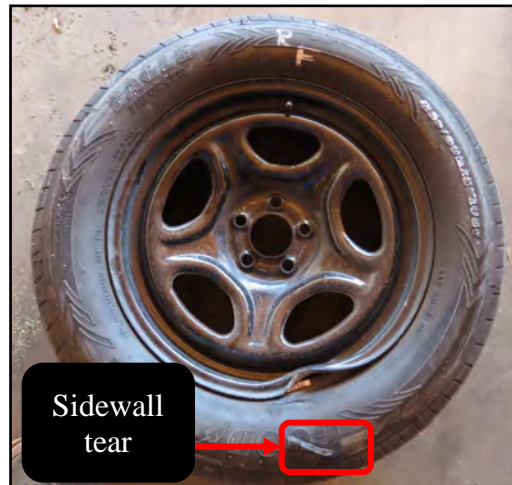
The right-front tire was debanded. The right-front outboard wheel flange sustained radial collapses at the 5 o'clock position, and the outboard sidewall sustained a tear at the same position (Figure 27).

Figure 27. Outboard view of right-front tire and wheel assembly.

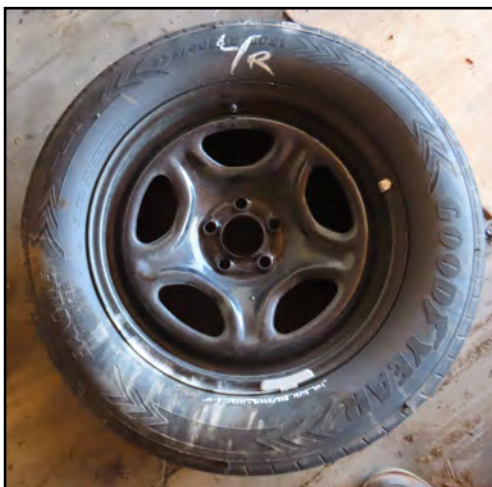
Figure 28. Outboard view of left-rear tire and wheel assembly.

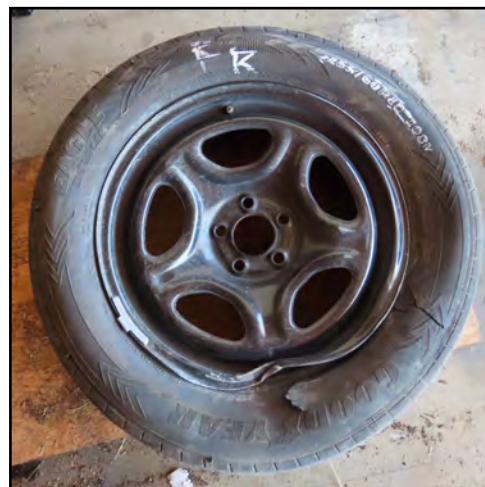
The left-rear outboard sidewall sustained tears and cuts at the 5 and 6 o'clock positions, and the outboard wheel flange sustained a radial collapse at the 5 o'clock position (Figure 29).

Figure 29. Outboard view of right-rear tire and wheel assembly.

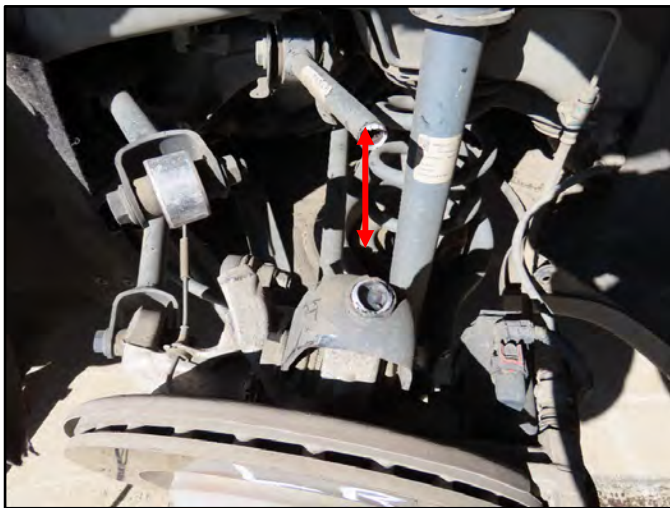
The rear knuckles were suspended from the vehicle frame by upper control arms, lower control arms, and a trailing arm. Coil springs were mounted between the frame and its corresponding lower control arm. Strut assemblies at each side dampened the suspension. A sway bar supplemented the suspension. The left-rear suspension sustained fractures and detachments to the upper control arm and steering knuckle (Figure 34 and Figure 35). The exposed fractured surfaces had a rough crystalline appearance.

Figure 34. Fractured upper control arm.

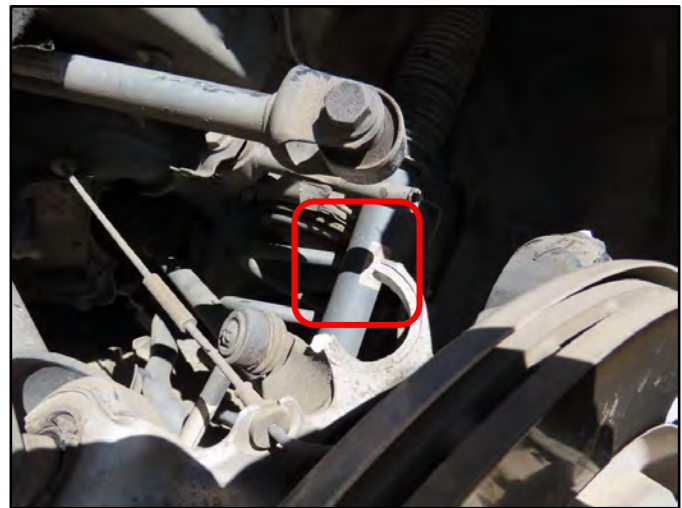
Figure 35. Fractured rear knuckle.

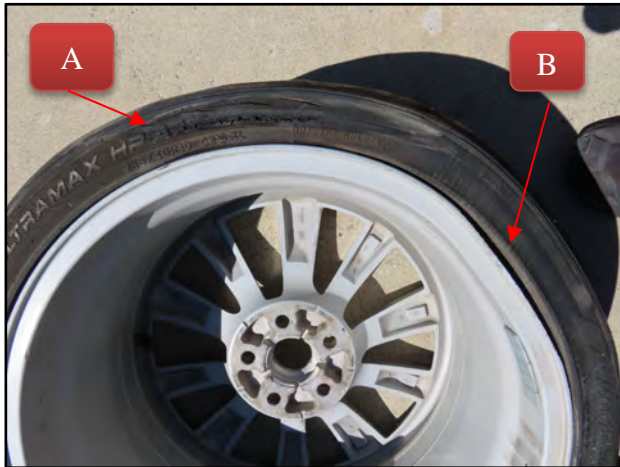
The left-rear tire sustained a perforating tear from the 3 to 5 o'clock positions of the inboard sidewall (Figure 36:A). The left-side inboard wheel flange sustained a radial bend from the 5 to 6 o'clock positions (Figure 36:B). The left-rear tire sustained wear that extended into the reinforcement plies. The wear was limited to the inner tread block of the tread package (Figure 37). This is a pre-existing condition caused by improper wheel alignment. The tread wear condition was not relevant to the crash.

Figure 36. Inboard view of the left-rear tire and wheel damage.

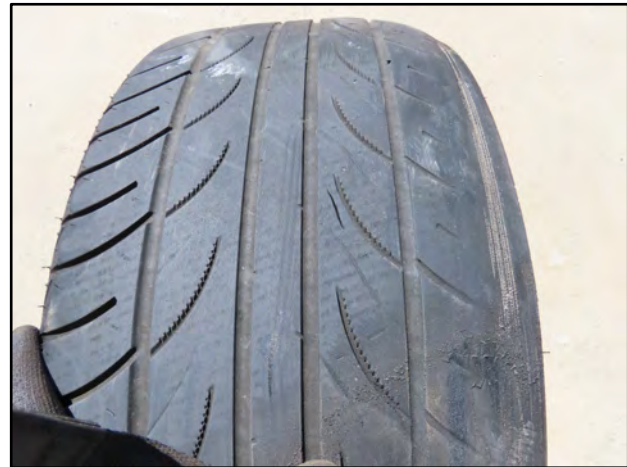
Figure 37. View of the left-rear tread package wear.

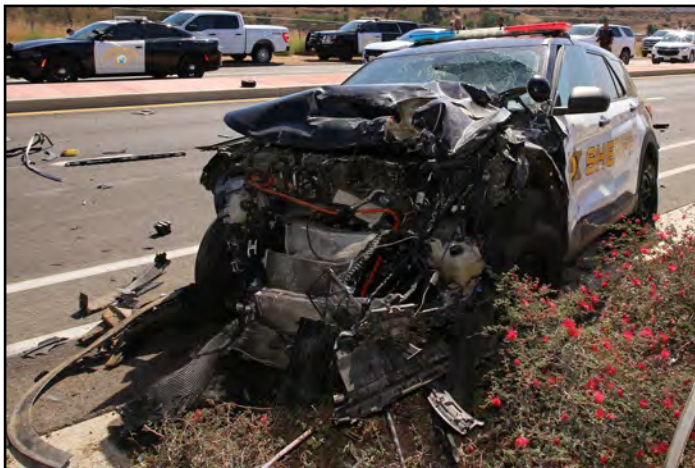
The Ford sustained damage to the front, left and right sides, rear, and undercarriage (Figure 39 and Figure 40). Prior to imaging, the following was noted:

Figure 39. Front and left side of the Ford.

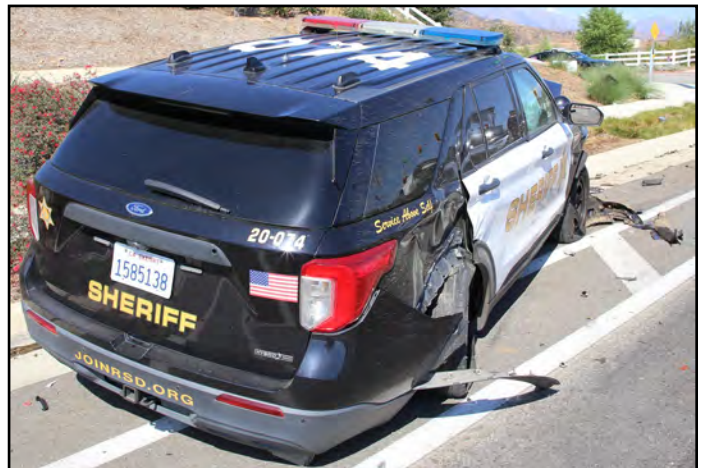
Figure 40. Rear and right side of the Ford.

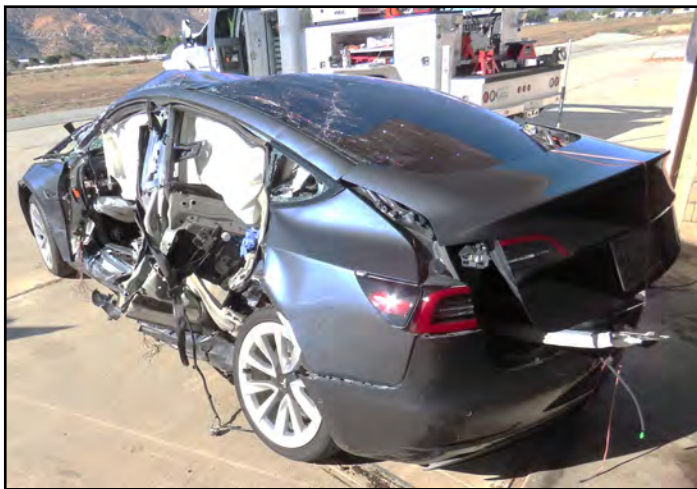
The Tesla sustained damage to the front, left and right sides, rear, and undercarriage (Figure 41 and Figure 42). Prior to imaging, the following was noted:

Figure 41. Rear and left side of the Tesla.

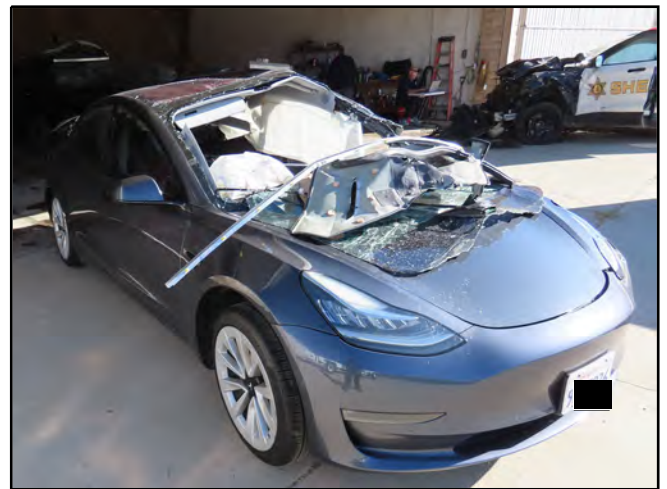
Figure 42. Front and right side of the Tesla.

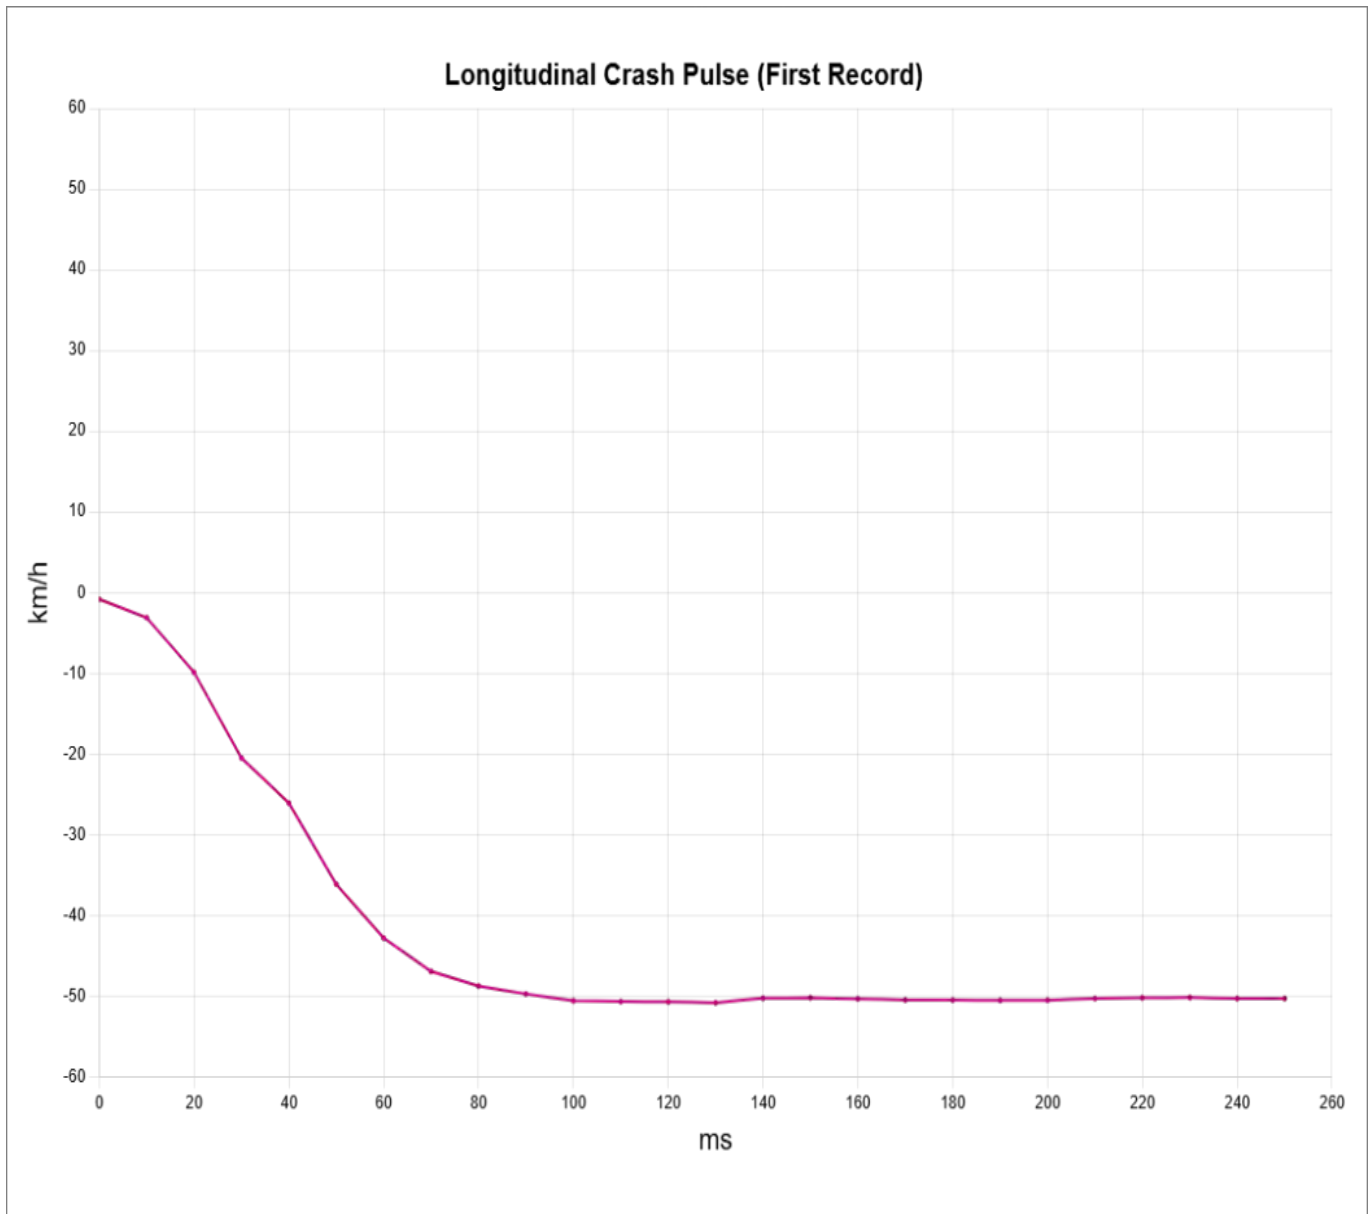
The cumulative longitudinal and lateral Delta-V values recorded during the First Record were indicative of a front-to-rear principal direction of force, with a left-to-right component. The graphs of the longitudinal and lateral crash pulses recorded during First Record were characteristic of a typical crash pulse, with no unusual reversals, and were consistent with the damage sustained by the front of the Ford.

Longitudinal Crash Pulse (First Record)

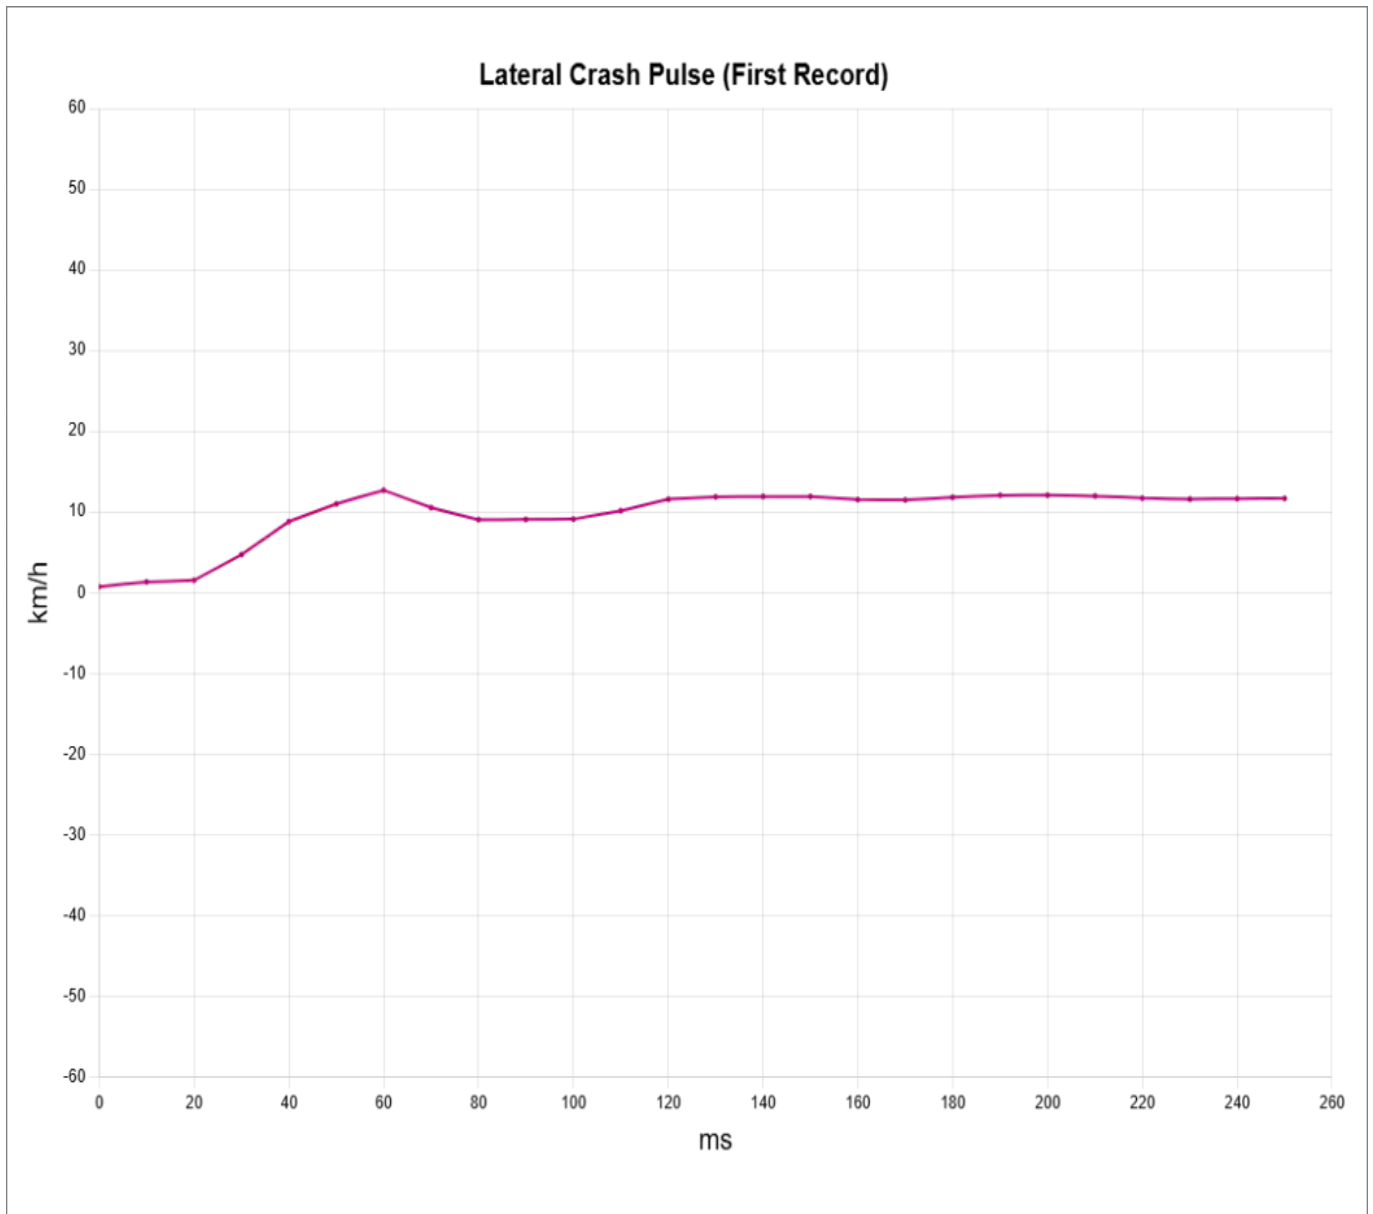
Lateral Crash Pulse (First Record)

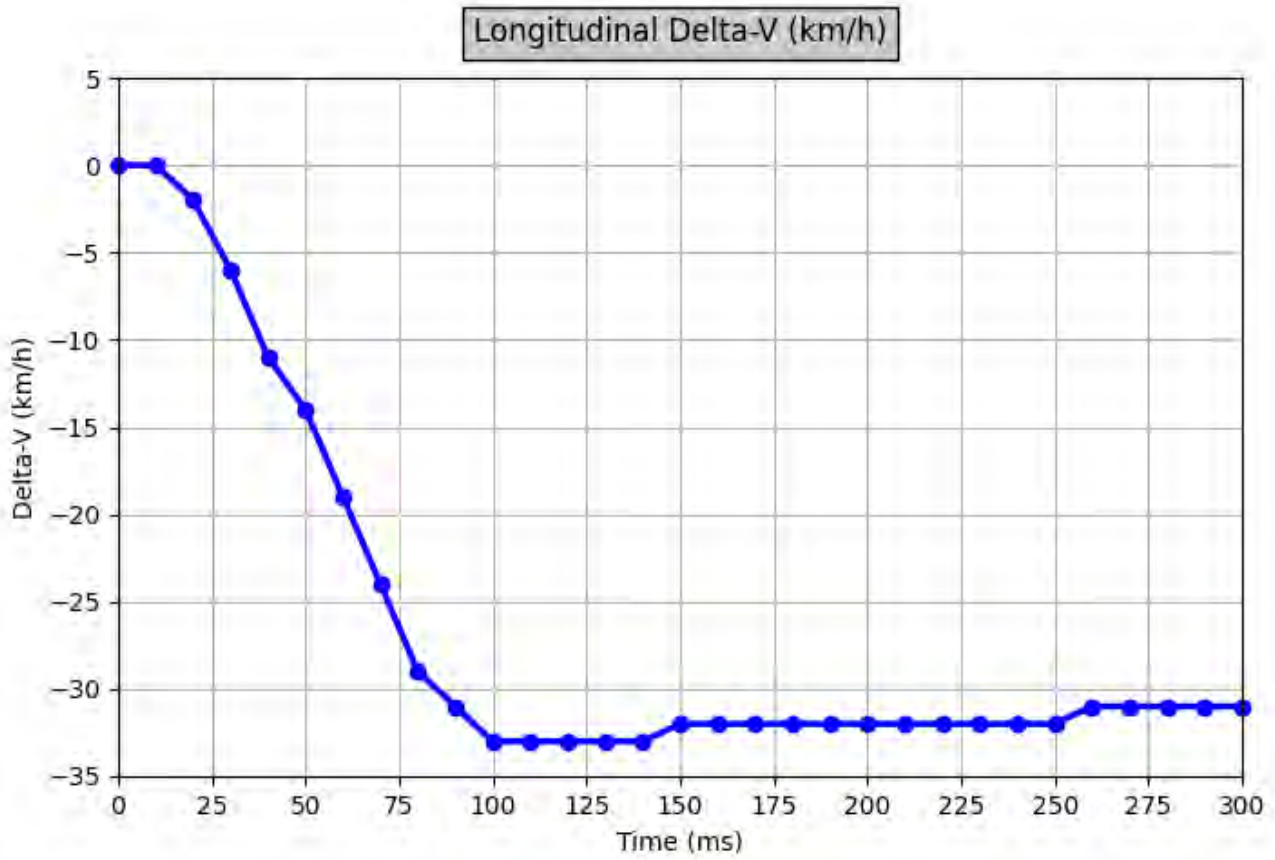
The cumulative longitudinal and lateral Delta-V values recorded during Event 1 were indicative of a left-to-right principal direction of force, with a front-to-rear component. The graphs of the longitudinal and lateral crash pulses recorded during Event 1 were characteristic of a typical crash pulse, with no unusual reversals, and were consistent with the damage sustained by the left side of the Tesla.

Longitudinal Delta-V (Event 1)

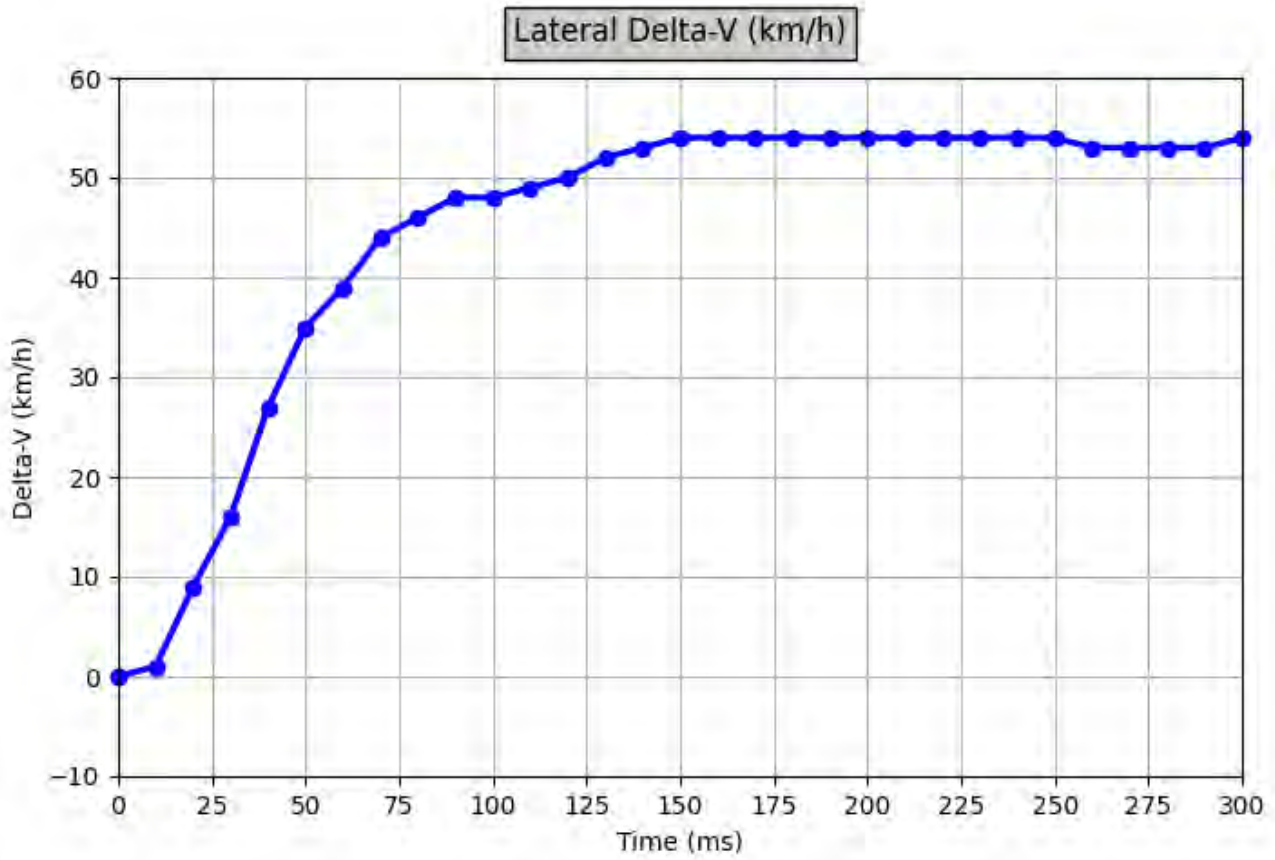
Lateral Delta-V (Event 1)
